**FINAL
ENVIRONMENTAL BASELINE SURVEY**

**OVER-THE-HORIZON BACKSCATTER
EAST (OTHB-E), MOSCOW, MAINE,
EAST COAST SITE**

February, 2007

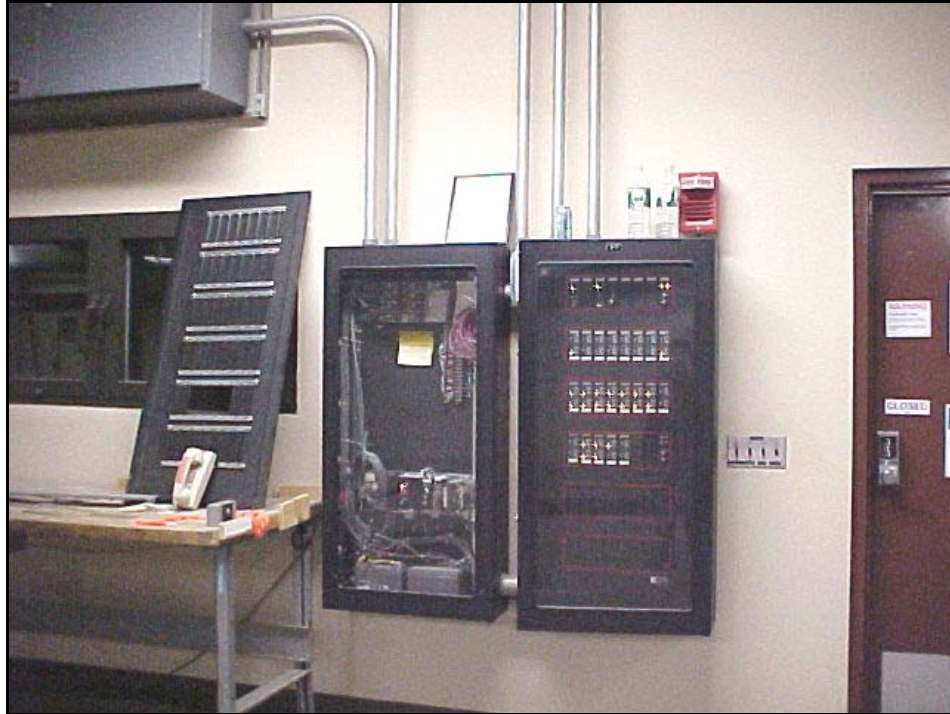
Picture 5: Alarm panel for equipment that has been removed

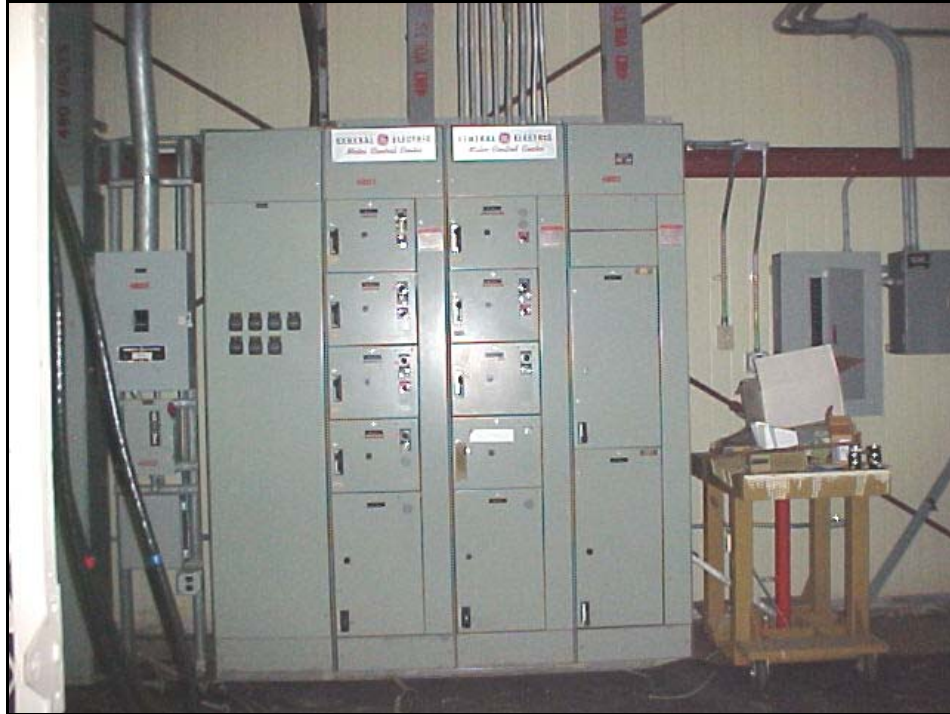
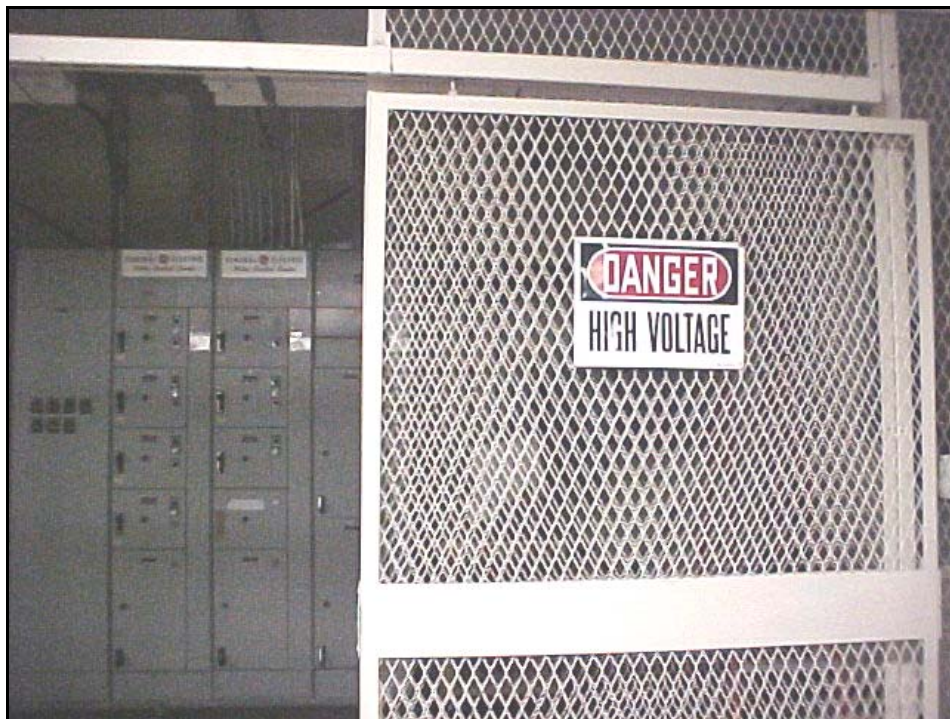
Picture 9: Panel is part of the UPS power system

Picture 10: Same as Picture 9

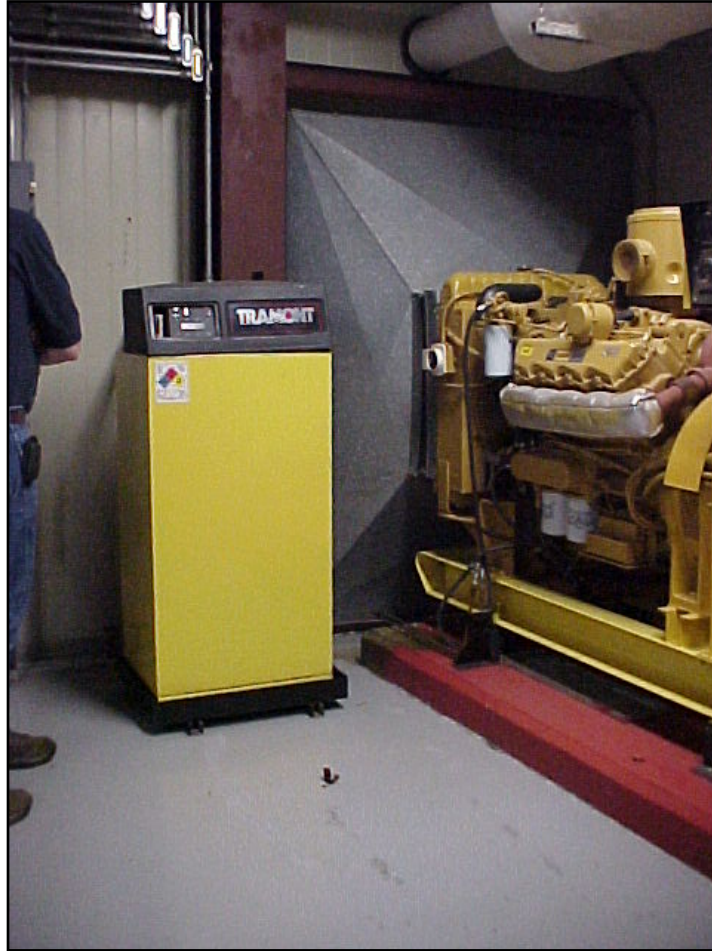
Picture 16: 75 gallon fuel tank for generator

Four (4) ASTs are present on site, one AST per sector, which are 75 gallons each and are used to hold diesel. The fourth AST in the garage of Sector 1 is 300 gallons and also contains diesel fuel. These ASTs do not require permits due to their sizes (the state of Maine does not require a permit for those ASTs 75 gallons and under). Permits were not found for this site with the Fire Marshall's Office (Steve Dixon, Maine Fire Marshall's Office). Lastly, a 75,000 gallon water tank is located on site, but it is currently empty. A building specification for the large water tank can be found in Appendix G-4 under Building Specifications.

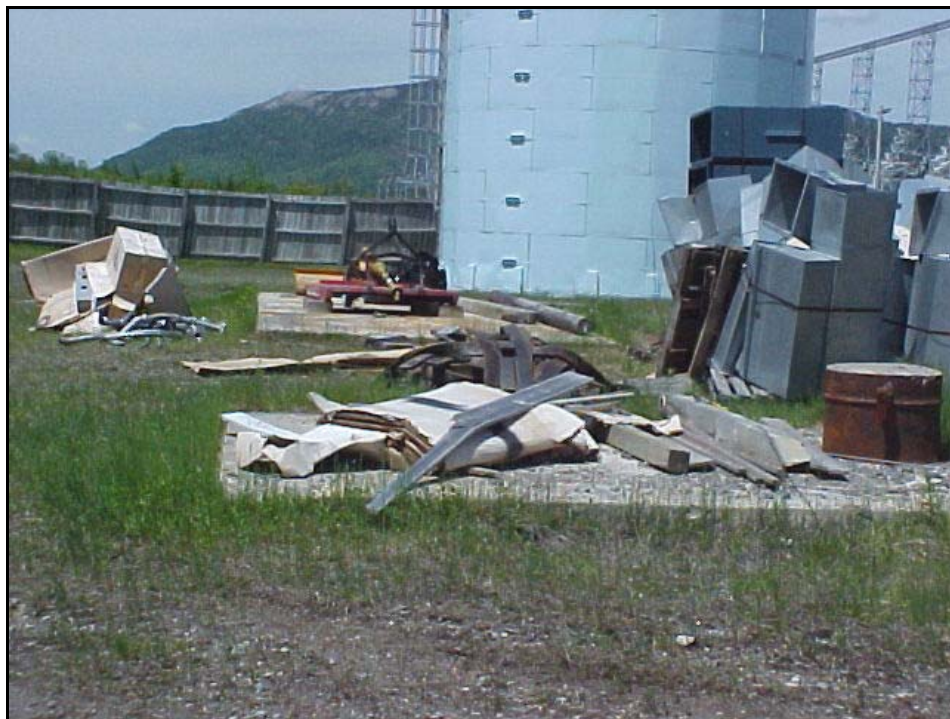
Picture 23: Scrap metal that will be transferred to DRMO

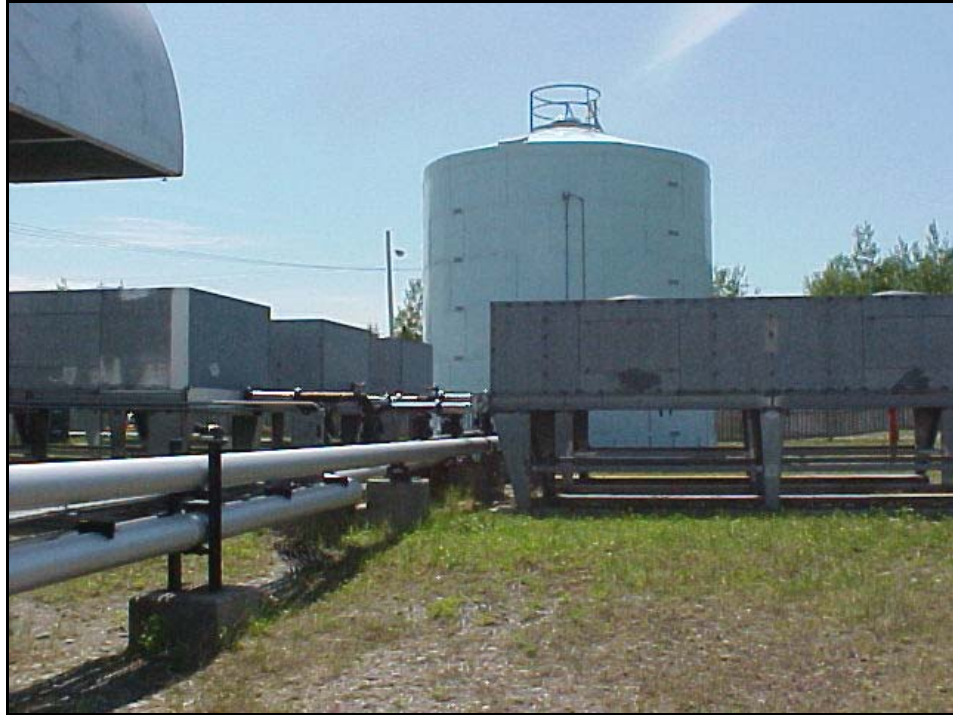
Picture 26: 75,000 gallon water storage tank in background and heat rejecters for glycol cooling system for transmitters

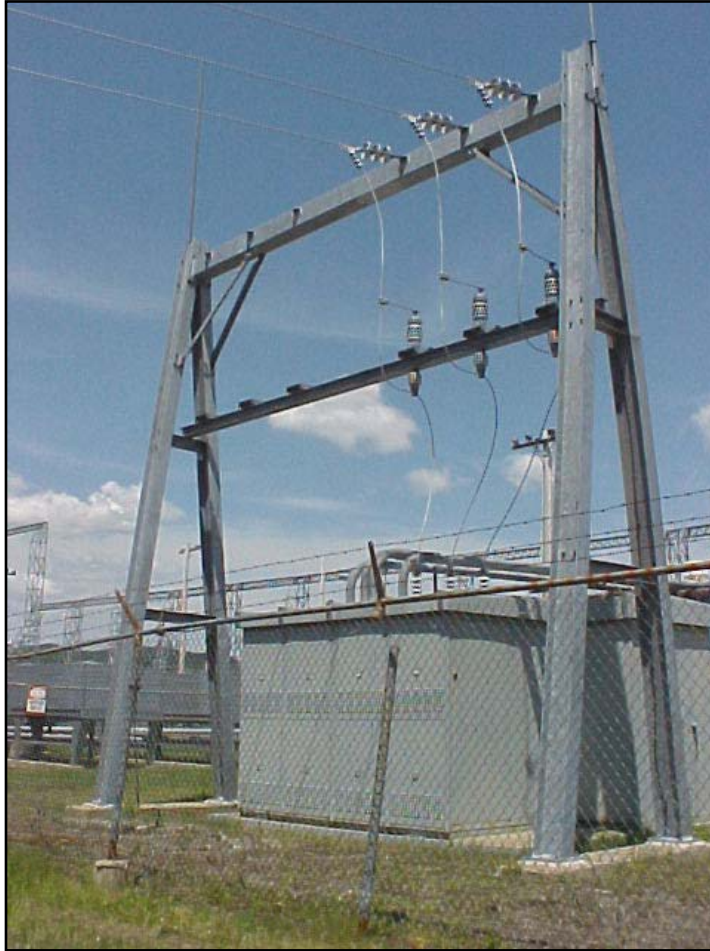
Picture 27: High voltage connection and transformers for Sector 1

Polychlorinated biphenyls (PCBs) can be found in electrical transformers and may also be contained within the ballasts of older fluorescent light fixtures. A number of transformers are present on the OTHB-E transmitter site as seen in Table 2.13-1. No records of PCBs were available and OTHB-E staff report that transformers are labeled “no PCBs.” No spills of liquids from transformers have been recorded at this transmitter site. All transformers that are not related to lighting have already been removed. Appendix G-3 also contains specifications for the buildings, transformers, and other aspects of the Site.
